Town of Meaford
Meaford Public Library
15 Trowbridge Street West
Meaford, Ontario.
N4L 1V4

On Tuesday June 10, 2003, Meades Engineering Limited visited the Meaford Public Library to conduct an inspection and assessment of the building structure. This building was constructed in 1935 by the Federal Government to serve as a Post Office on the main floor and a Custom and Excise Office on the second. Unfortunately original drawings for this building could not be found. Most of the structural framing members are concealed behind the interior finishes so a complete analyses with respect to strength and serviceability of framing members was not possible. While on site, a probe hole was cut at the second floor to determine the size of floor joists and the steel beams.

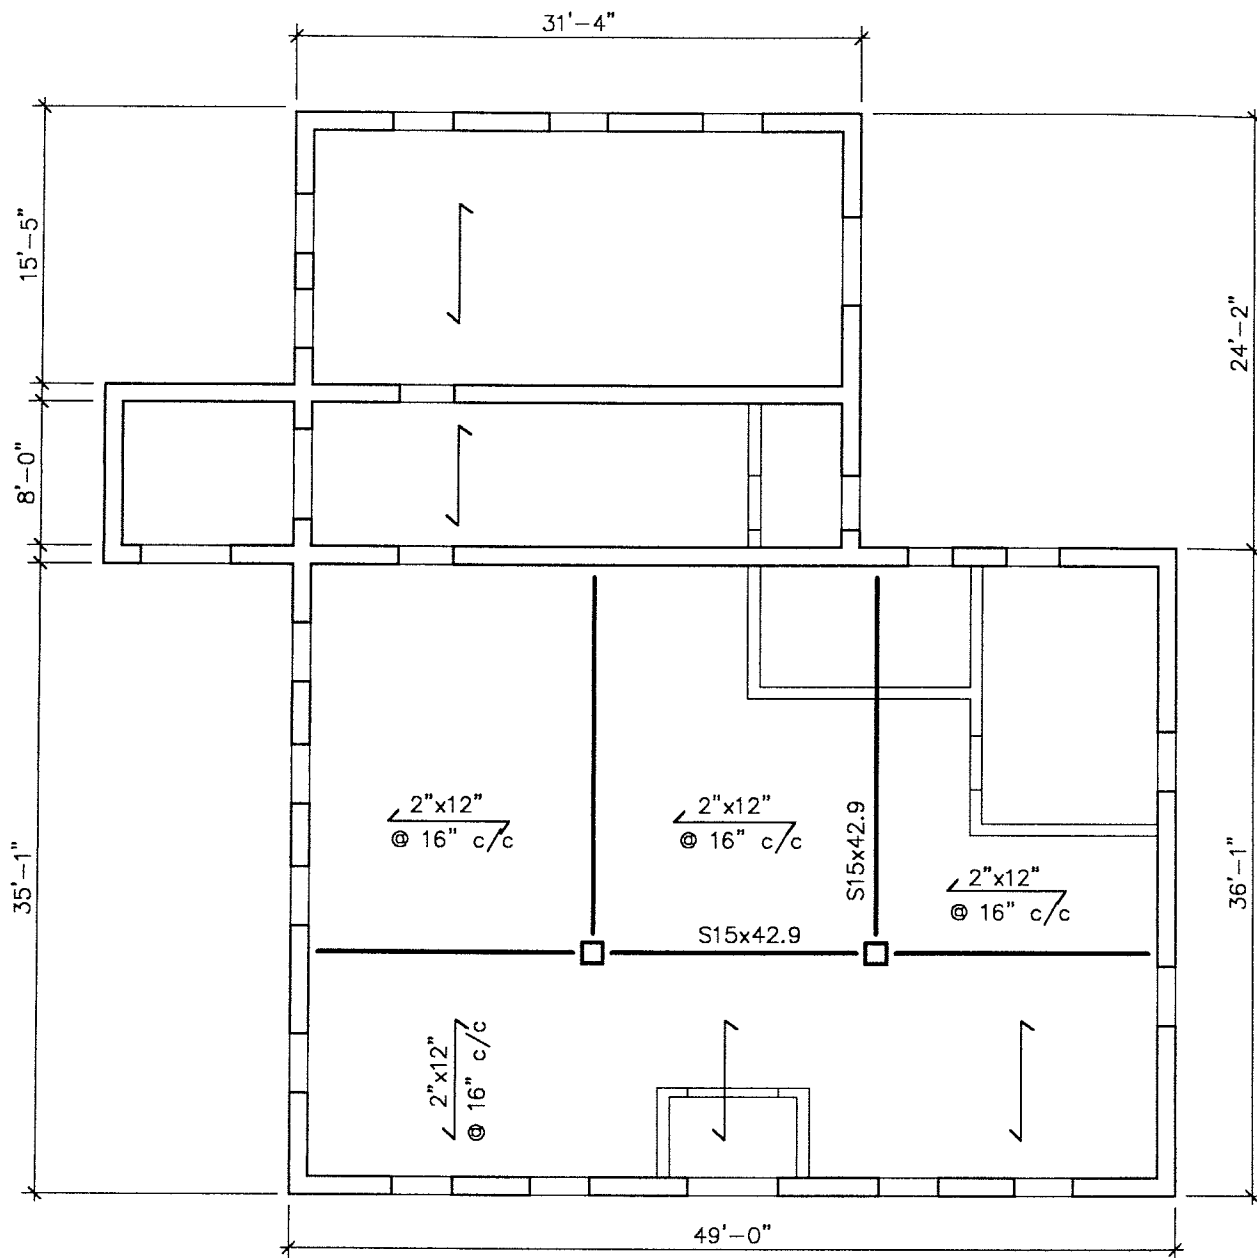
SECOND FLOOR FRAMING

Framing for the second floor was determined at the exploratory hole. Floor joists consist of 2"x12" (actual size) spaced to 16" centres and these are supported on steel beams. Based on their depth being 15" and with a flange width of 5 ¼, they were determined to be S15x42.9, I beams with tapered flanges.

Analysis of the joists indicates that their safe live load capacity is 106 psf where they span 15'-8" and 167 psf for the 13'-0" span. For the steel beams the safe floor load capacity of 100 psf at the 22'-0" span and 460 psf at the 15'-8" span. These numbers suggest the second floor is quite strong and suitable for residential and offices. With respect to the Ontario Building Code, stack areas in Libraries require a safe floor loading of 150 psf. Therefore, only part of the second floor is suitable for Library occupancy.

Expanding the Library into the second floor will require strengthening of the structure where the load rating is below 150 psf as required by Code for stack areas. To do this, the structure would have to be exposed which means that the first level would have to be vacated when this is done. Also, expansion into the second floor will require an elevator as buildings now must be accessible to the handicapped.
