## **PROJECT FILE REPORT BRIDGE BR-125 REPLACEMENT**

### **MUNICIPAL CLASS ENVIRONMENTAL ASSESSMENT – SCHEDULE B –**

Prepared For:  
**The Municipality of Meaford**  
21 Trowbridge Street West  
Meaford, Ontario, N4L 1N2

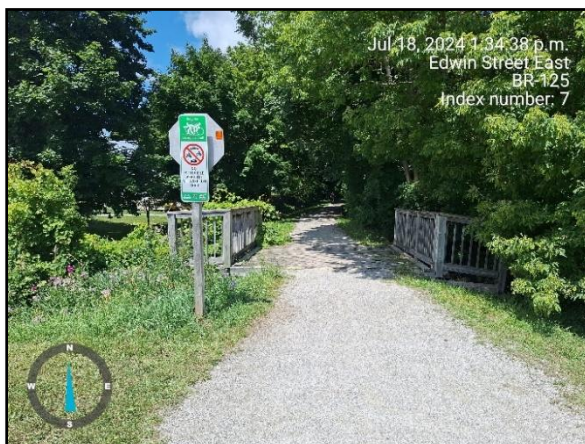
**Images 1 and 2** – View of BR-125 along Georgian Trail, looking north (left); View of BR-125 from Meaford Creek, looking west (right)

Based on a visual inspection, the guardrails and deck appear to be newer than the rest of the structure which is consistent with the bridge's conversion from railway to pedestrian bridge. The bridge was visually inspected by Centex on July 18, 2024. Select photos from this inspection can be found in **Images 1 and 2** below for general reference. The observations and findings of this inspection were found to be consistent with the findings presented in the most recent OSIM inspection report dated July 19, 2023, prepared by RJ Burnside. The bridge was identified as a candidate for replacement by RJ Burnside with replacement recommended within two (2) years. Critical to the recommendation that the bridge be replaced is the presence of severe deterioration of the timber piles at the waterline. This deterioration has significantly reduced the total cross-sectional area of the piles, with a corresponding reduction in load carrying capacity.

The wood guardrails are built using SPF lumber assemblies comprised of 2"x6" handrails, 6"x6" posts, 2"x2" spindles, and 2"x4" top rails. The guardrail posts are bolted to timber stringers (railway ties) with two (2) steel L-angles per post. The deck assembly is comprised of 2"x8" SPF lumber floorboards which sit on nine (9) 10"x10" timber stringers (railway ties), which are supported by ten (10) 16"x10" timber deck beams. Under each end of the deck beams are 14"x14" timber pile caps which sit on top of wood piles. Each end of the structure has ballast/wingwalls comprised of 12"x12" timber members.

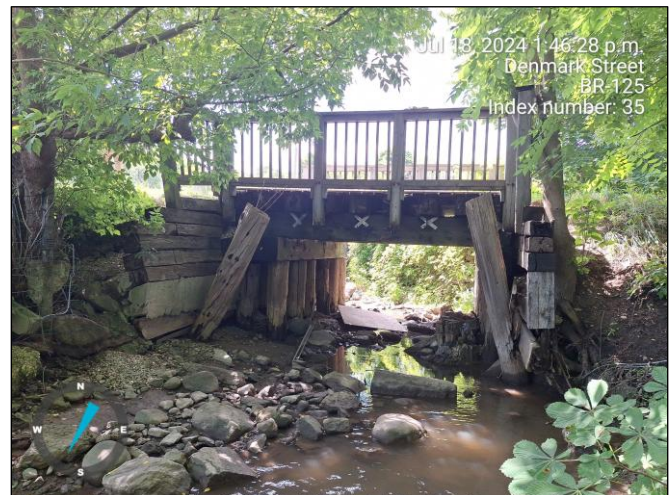
**Image A4** – East elevation.

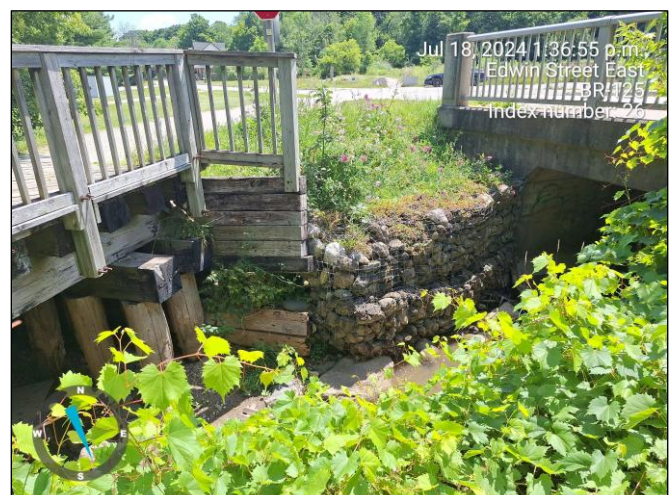
**Image A6** – Gabion baskets at southwest corner.

Gabion baskets were observed on the structure embankments. Some loss of gabion basket material was noted. The gabion baskets will likely need to be rehabilitated as part of the overall work. On the northwest side of the bridge, several of the piles have been destroyed and disconnected from the structure. Overall, the substructure of the bridge has deteriorated significantly over time, with several timber members missing from the wingwalls. Photos from the inspection can be found in **Appendix A**.

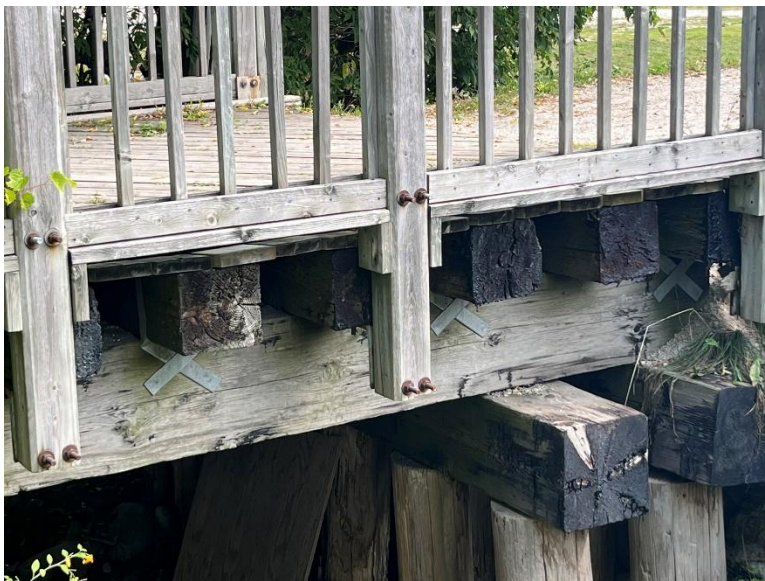
Figure 11: The bridge superstructure, the beams and railroad ties are visible beneath the railing (A.S.I., 2024)

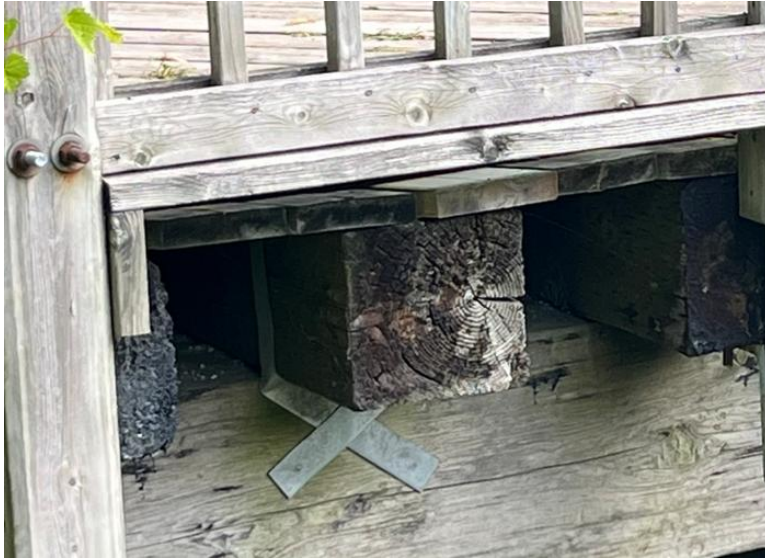
Figure 12: Detail view of the strapping connecting railroad ties to beams (A.S.I., 2024)

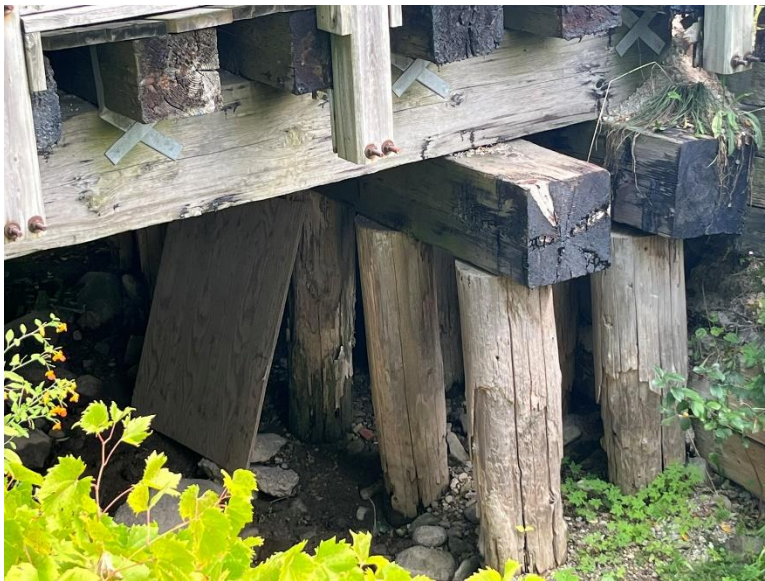
Figure 13: The bents on the eastern side of the bridge, note the leaning cap on the pier along the ballast wall (A.S.I., 2024)

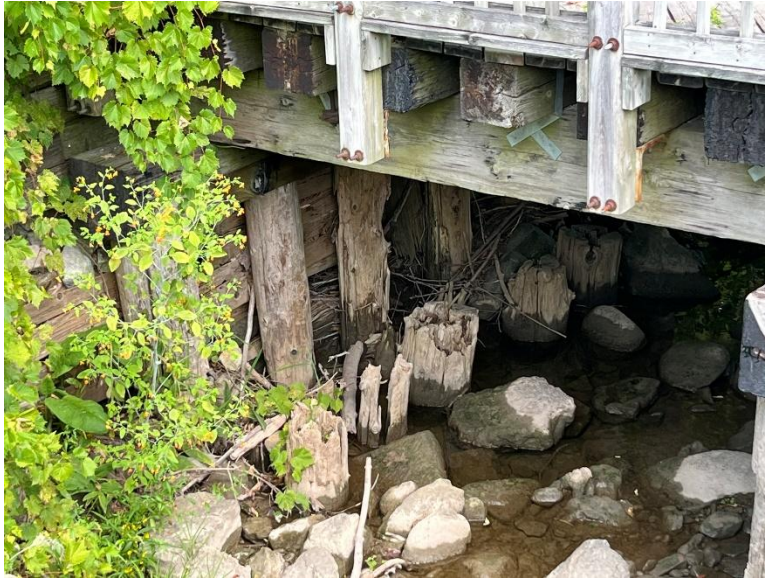
Figure 14: Detail view of the broken piles and severe deterioration on the western piers (A.S.I., 2024)

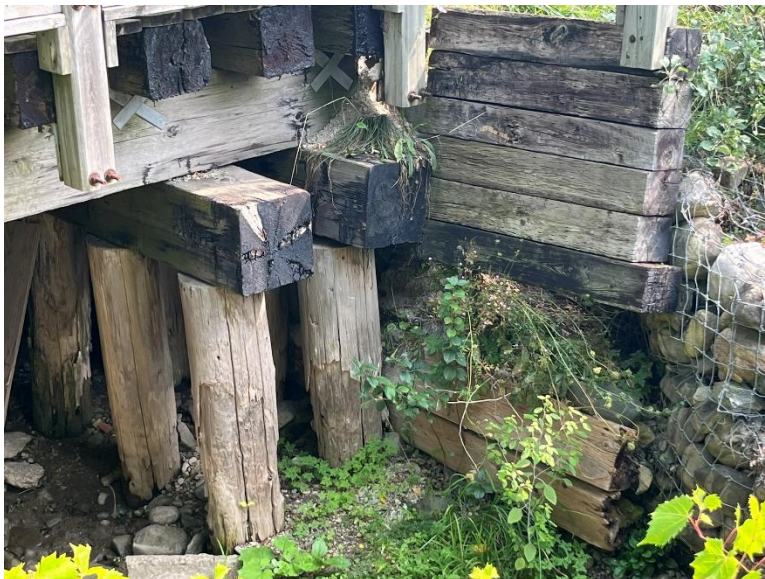
Figure 15: The southeastern ballast wall. Note the warping of the wall and vegetation growing through (A.S.I., 2024)

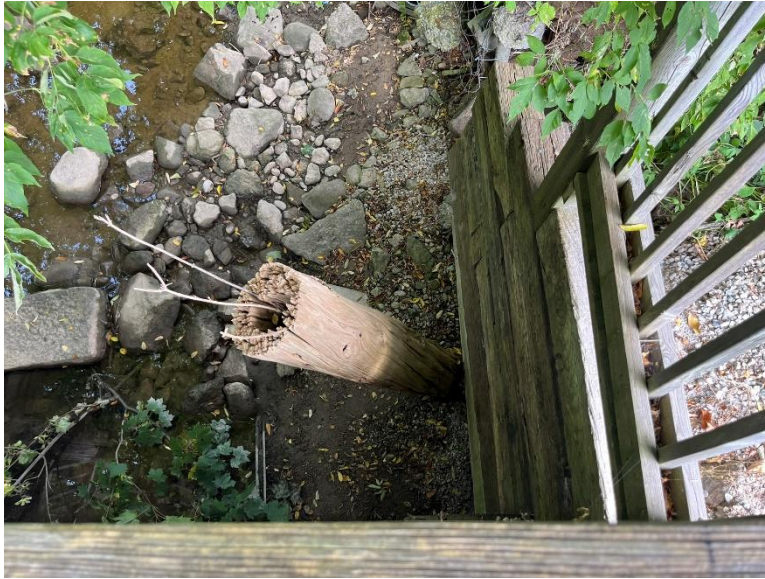
Figure 16: Detail view of the leaning northeastern ballast wall pile (A.S.I., 2024)

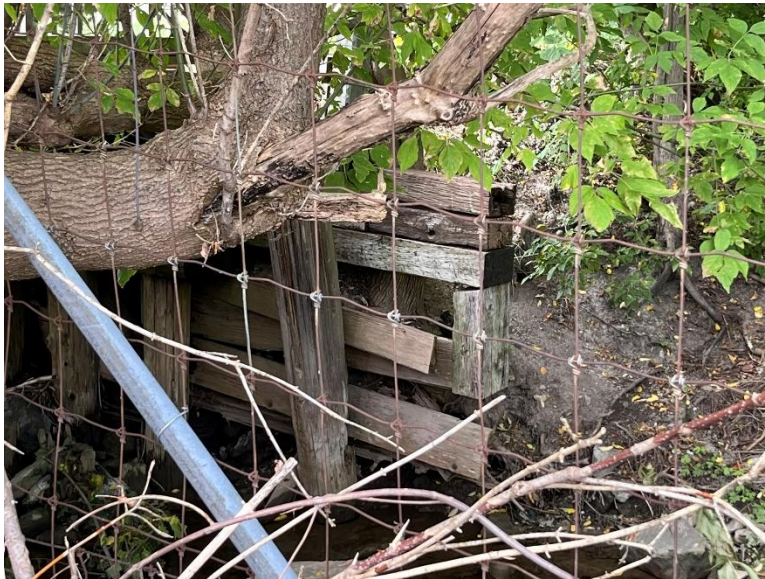
Figure 17: Detail view of the northwestern ballast wall. The tree pushing the wall inward is visible through the gap in the wall (A.S.I., 2024)

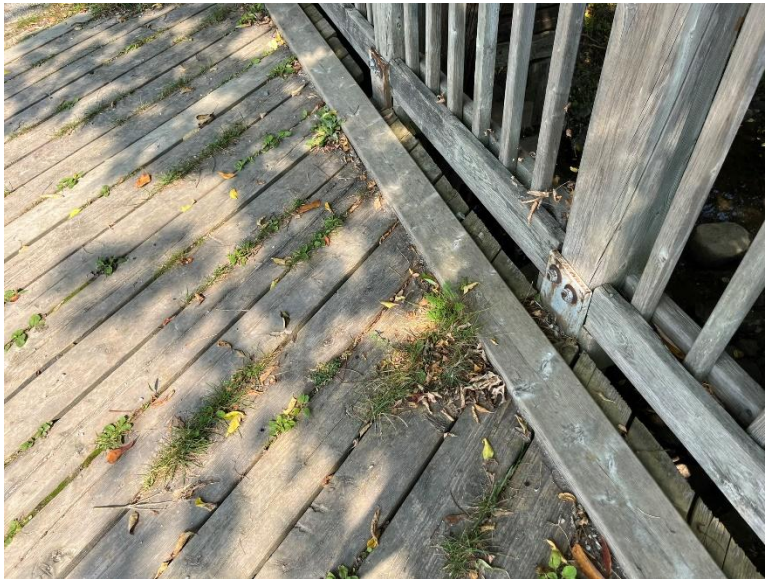
Figure 19: Detail view of the bridge deck and timber curb (A.S.I., 2024).

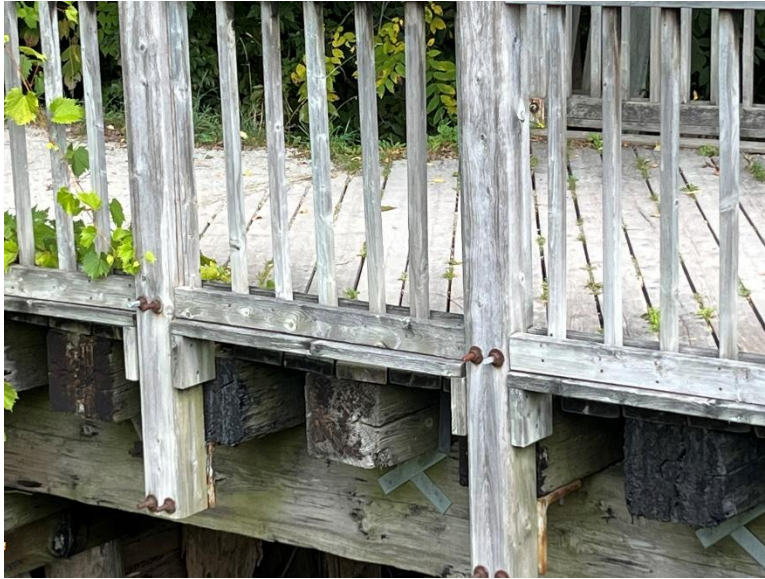
Figure 20: Detail view of the railing system on the southern elevation. Note the bolts connecting the railing to the superstructure (A.S.I., 2024).

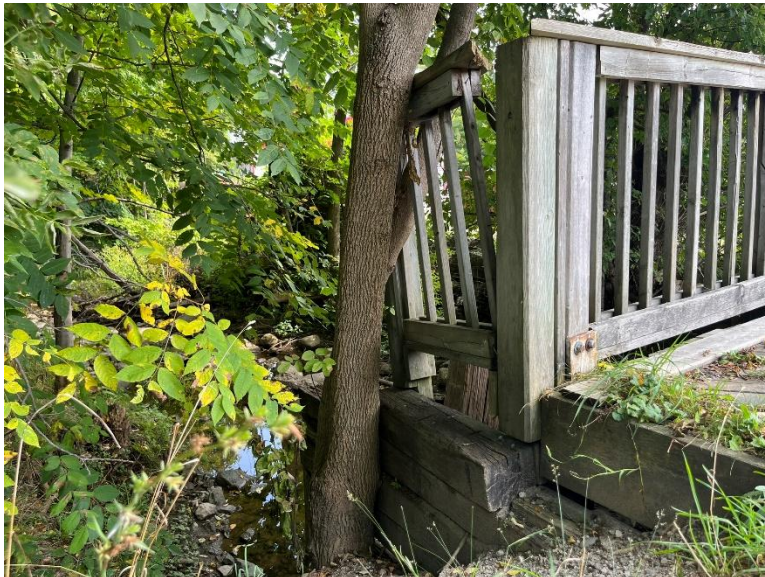
Figure 21: Detail view of the tree growing through the railing at the northwest ballast wall (A.S.I., 2024).

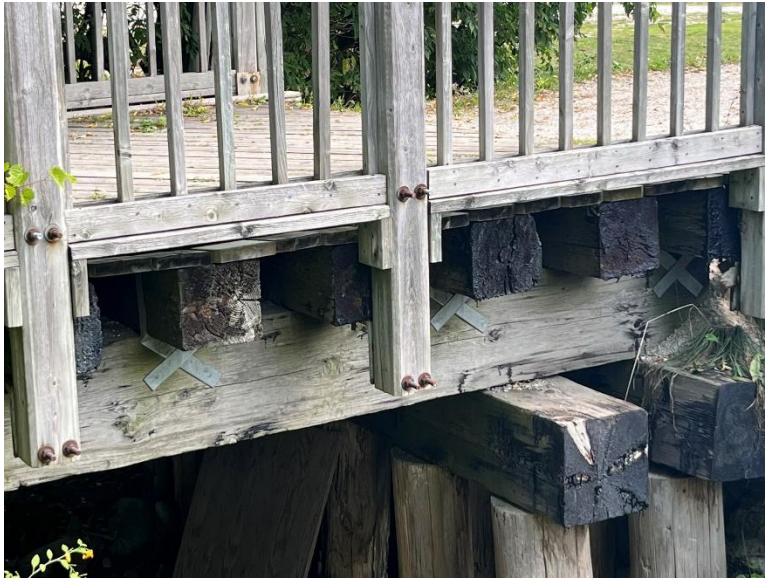
Figure 3: The bridge superstructure, the beams and railroad ties are visible beneath the railing (A.S.I., 2024)

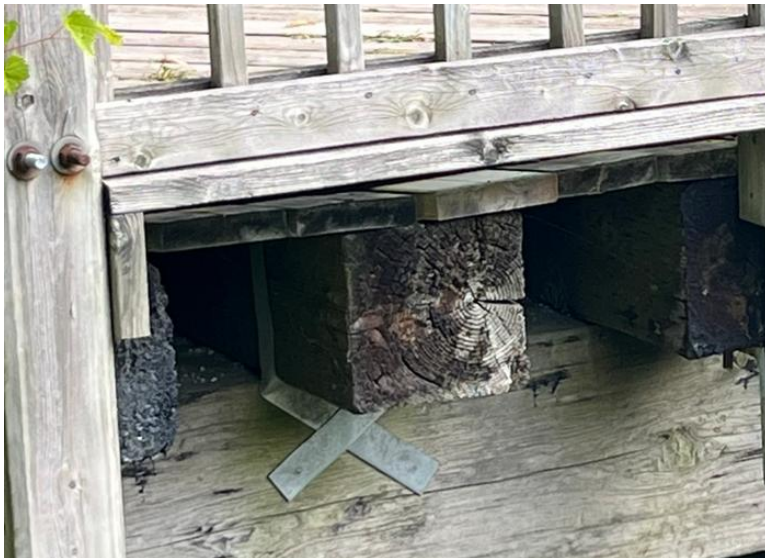
Figure 4: Detail view of the strapping connecting railroad ties to beams (A.S.I., 2024)

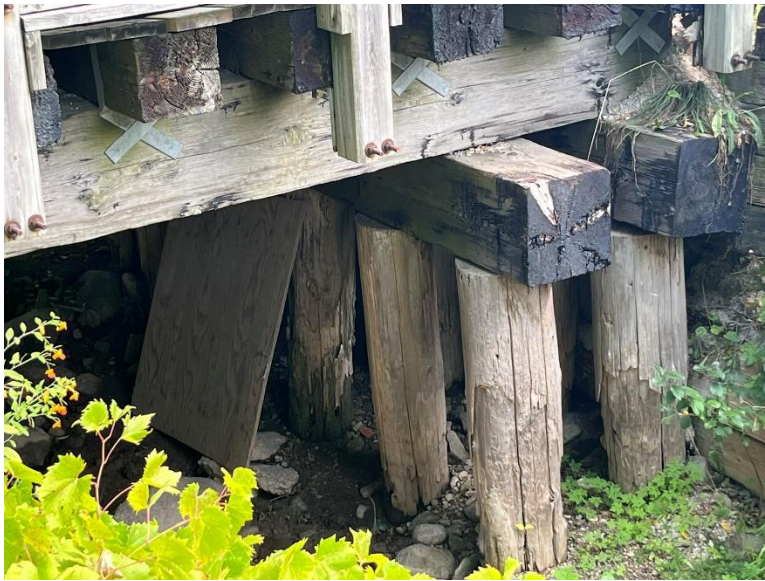
Figure 5: The bents on the eastern side of the bridge, note the leaning cap on the pier along the ballast wall (A.S.I., 2024)

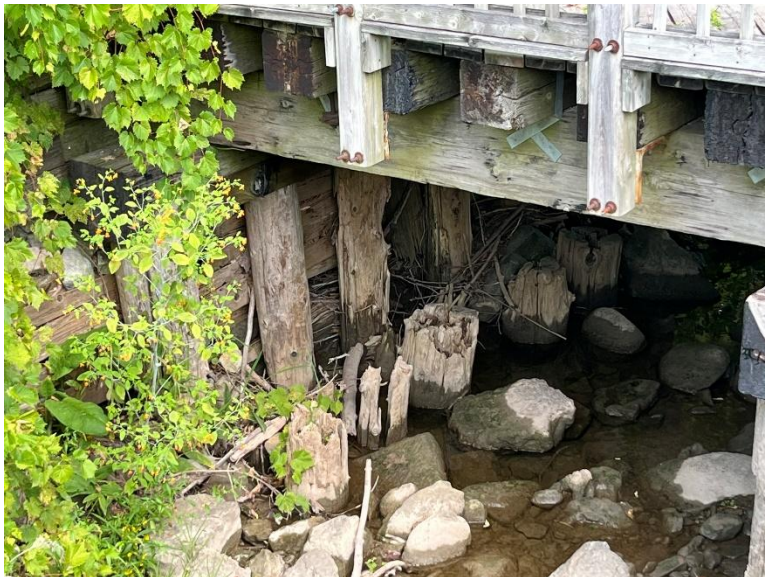
Figure 6: Detail view of the broken piles and severe deterioration on the western piers (A.S.I., 2024)

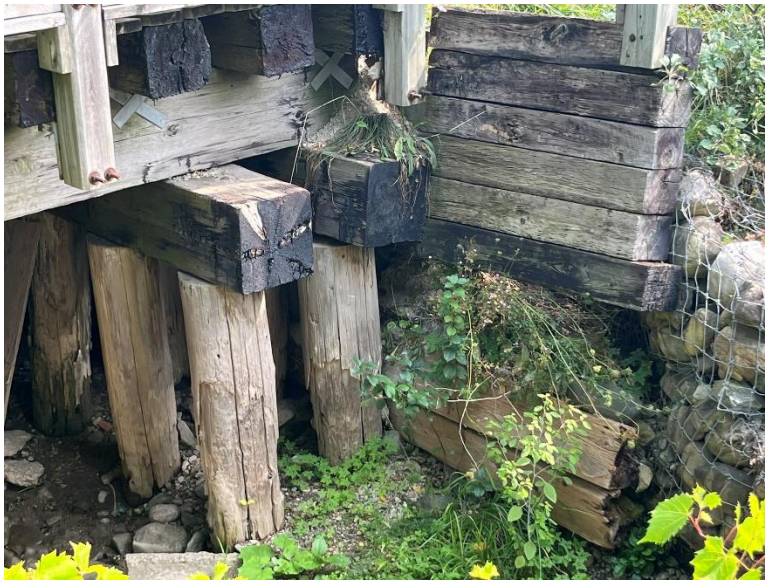
Figure 7: The southeastern ballast wall. Note the warping of the wall and vegetation growing through (A.S.I., 2024)

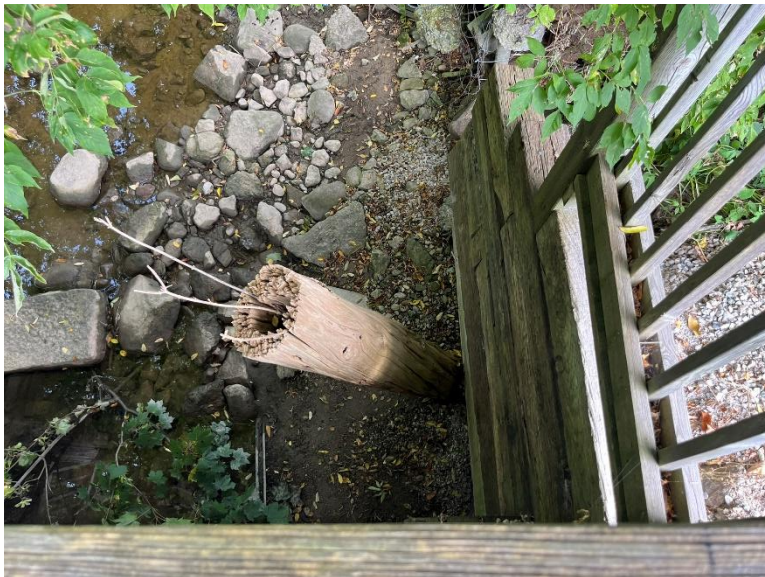
Figure 8: Detail view of the leaning northeastern ballast wall pile (A.S.I., 2024)

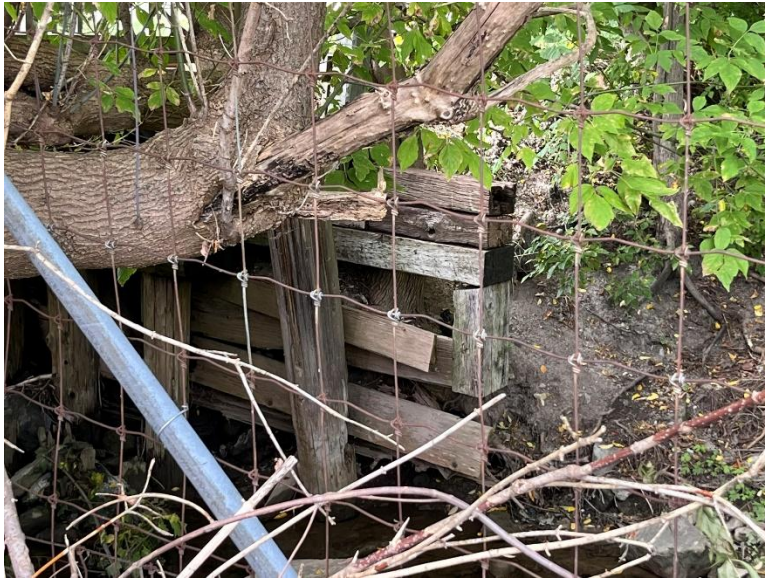
Figure 9: Detail view of the northwestern ballast wall. The tree pushing the wall inward is visible through the gap in the wall (A.S.I., 2024)

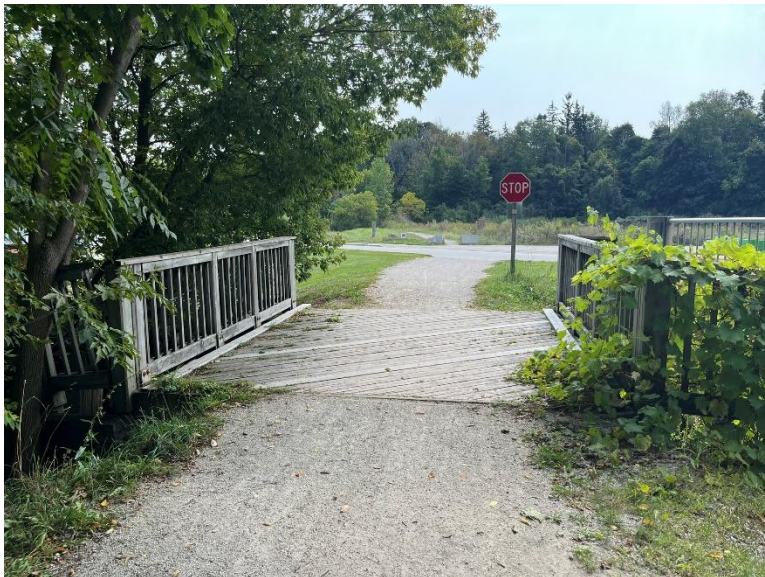
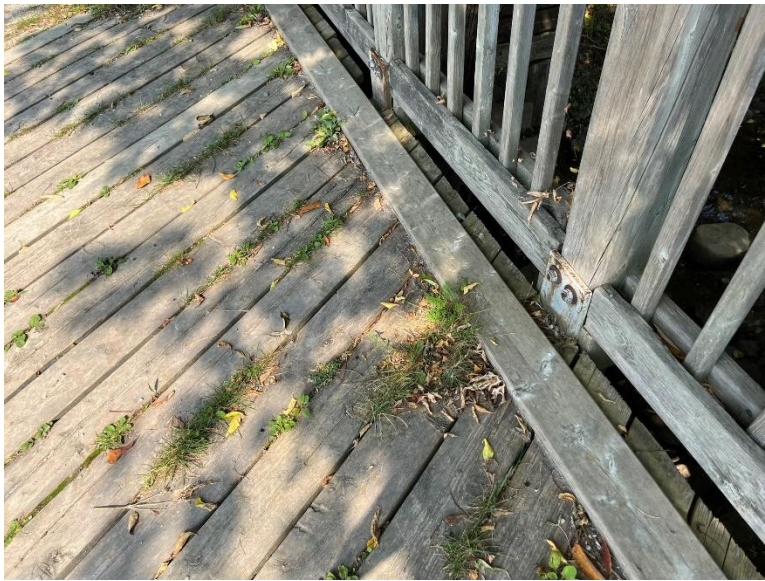
Figure 10: The timber bridge deck, looking southeast (A.S.I., 2024).

Figure 11: Detail view of the bridge deck and timber curb (A.S.I., 2024).

The deck of the subject bridge is constructed of timber planks laid diagonally across the width of the structure with timber curbs on either side (Figure 10 and Figure 11). There are timber railings which are bolted to the exterior of the superstructure. The timber deck and railing system were likely added when the bridge was converted for pedestrian use in 1989 and seem to be in good condition (Figure 12). At the northwest portion of the ballast wall, a tree growing alongside the wall has wound itself through the railing. The railing and a small portion of the bridge deck are overgrown with ivy at the southwest portion of the ballast wall (Figure 13).

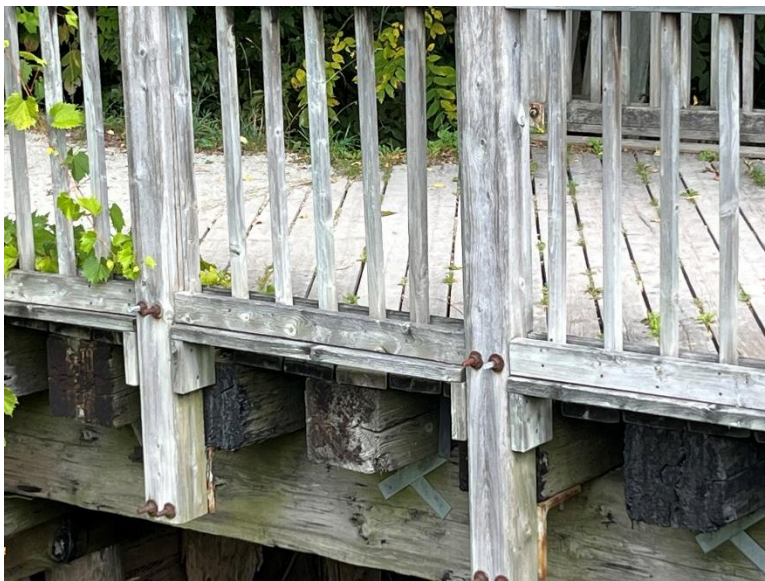
Figure 12: Detail view of the railing system on the southern elevation. Note the bolts connecting the railing to the superstructure (A.S.I., 2024).

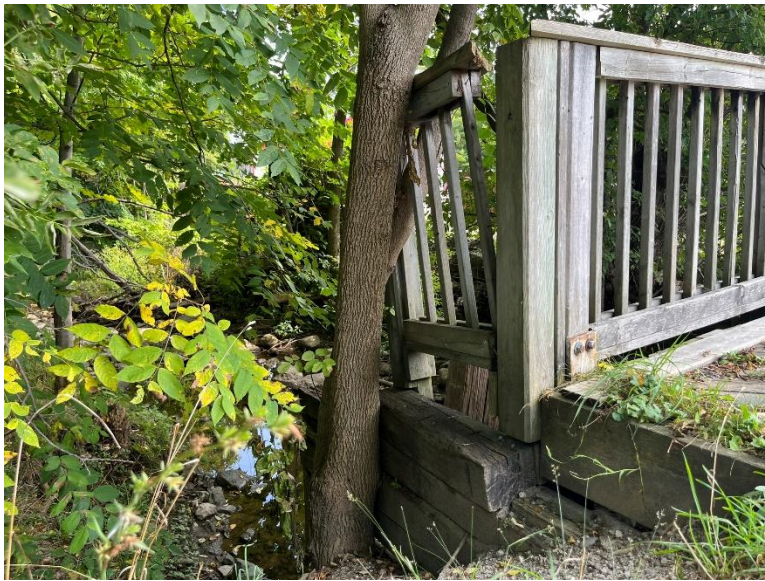
Figure 13: Detail view of the tree growing through the railing at the northwest ballast wall (A.S.I., 2024).
