# Heritage Impact Assessment

## Meaford Bridge No. 125

### Municipality of Meaford, Ontario

#### Draft Report

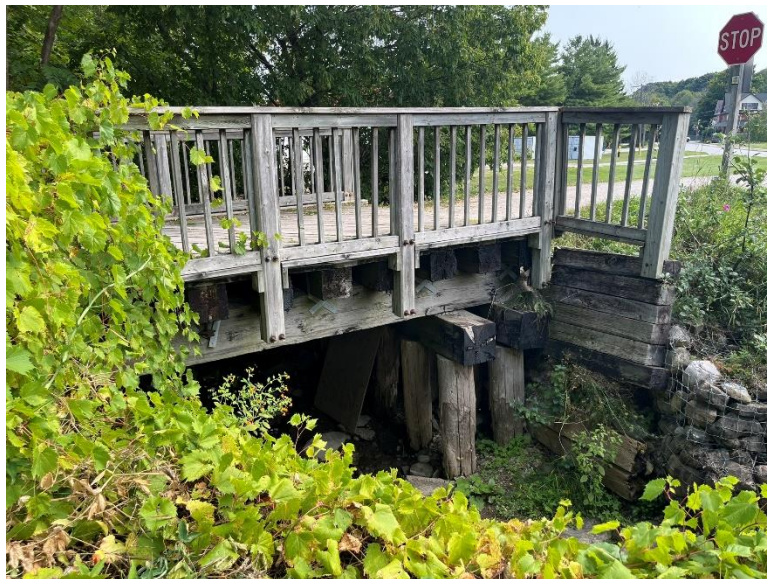
The superstructure of the subject bridge consists of timber girders which run the length of the bridge across Meaford Creek (Figure 2). Above these beams, running in a perpendicular direction, are creosote-treated timber railroad ties (Figure 3). Every second railroad tie is attached to the timber beams by metal strapping at either end (Figure 4). The beams and ties appear to be good condition with few signs of deterioration.

Figure 2: South elevation of the subject bridge, looking northeast (A.S.I., 2024)

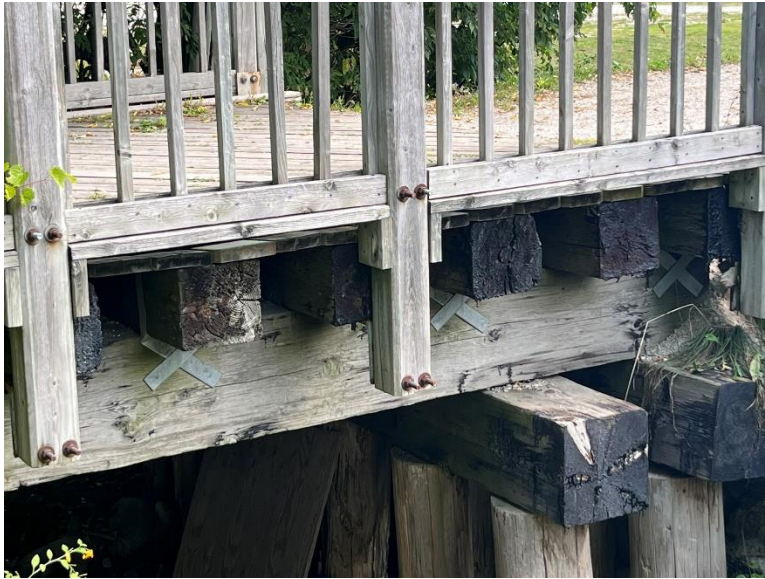
Figure 3: The bridge superstructure, the beams and railroad ties are visible beneath the railing (A.S.I., 2024)

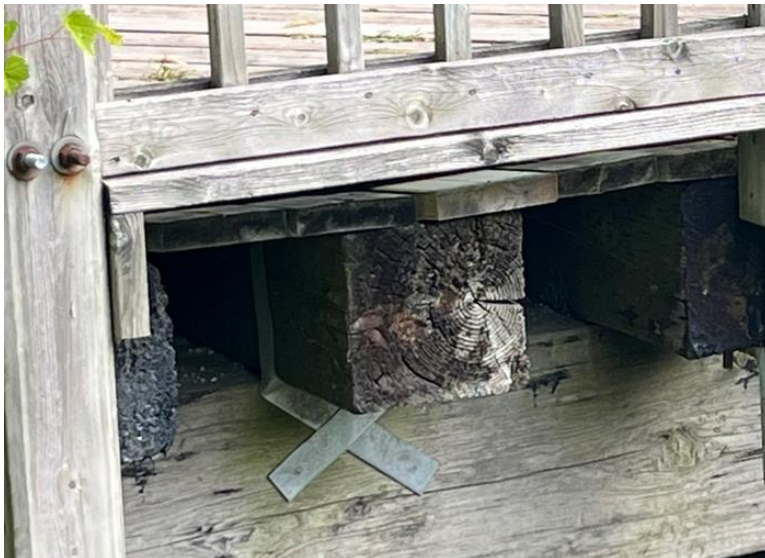
Figure 4: Detail view of the strapping connecting railroad ties to beams (A.S.I., 2024)

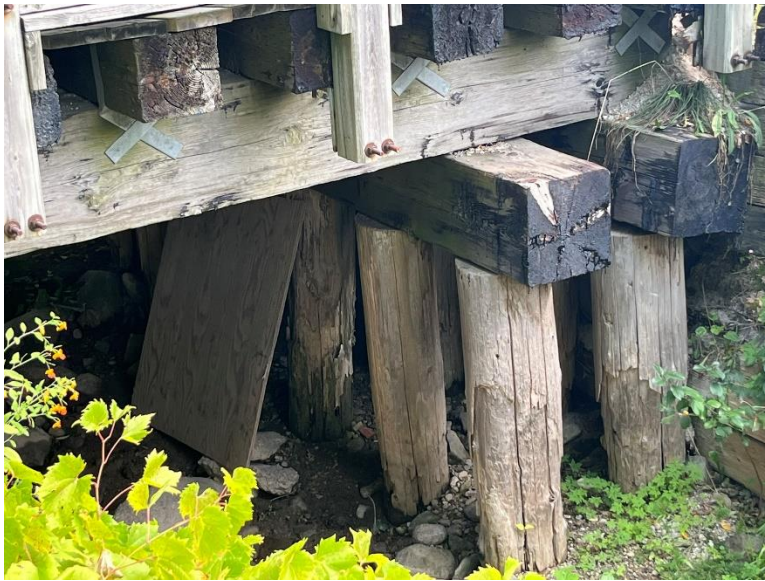
The substructure of the subject bridge features timber abutments and timber bents. There are two sets of bents on either side of the creek. Each of these bents are constructed of six piles made of timber with a timber crossbeam forming the pile cap and supporting the girders above (Figure 5). These bents show considerable signs of damage, particularly on the west side of the bridge where the bent closest to the waterway appears to have been completely washed away. The central piles of the bent behind, along the abutment wall, are also severely damaged (Figure 6). The remaining bents are intact, but show considerable damage and deterioration, particularly near the waterline. The cap of the bent at the eastern abutment has begun to collapse toward the abutment. The subject bridge's ballast walls are constructed of stacked timbers that extend beyond the width of the superstructure on either side. The ballast walls on both sides of the waterway have begun to collapse inward (Figure 7).

Figure 5: The bents on the eastern side of the bridge, note the leaning cap on the pier along the ballast wall (A.S.I., 2024)

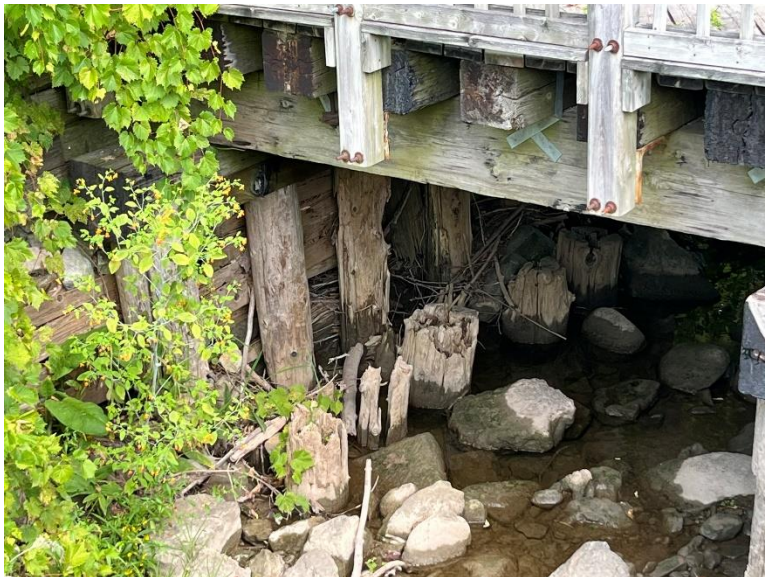
Figure 6: Detail view of the broken piles and severe deterioration on the western piers (A.S.I., 2024)

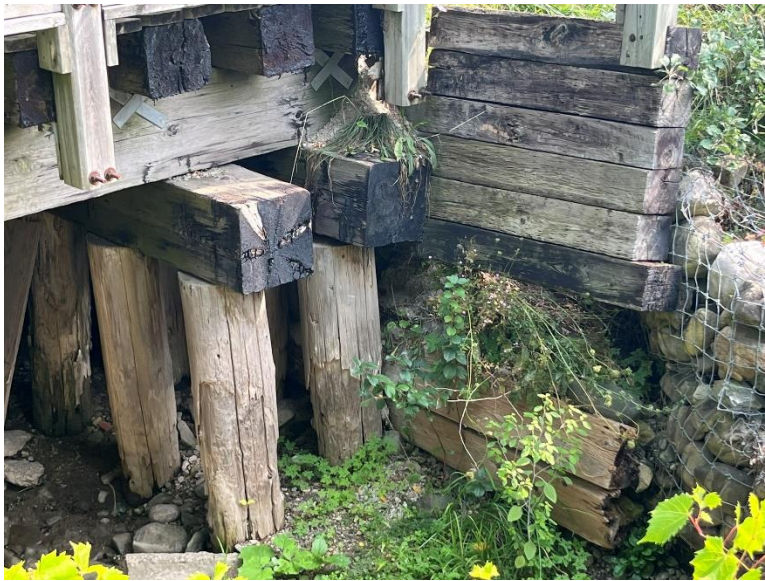
Figure 7: The southeastern ballast wall. Note the warping of the wall and vegetation growing through (A.S.I., 2024)

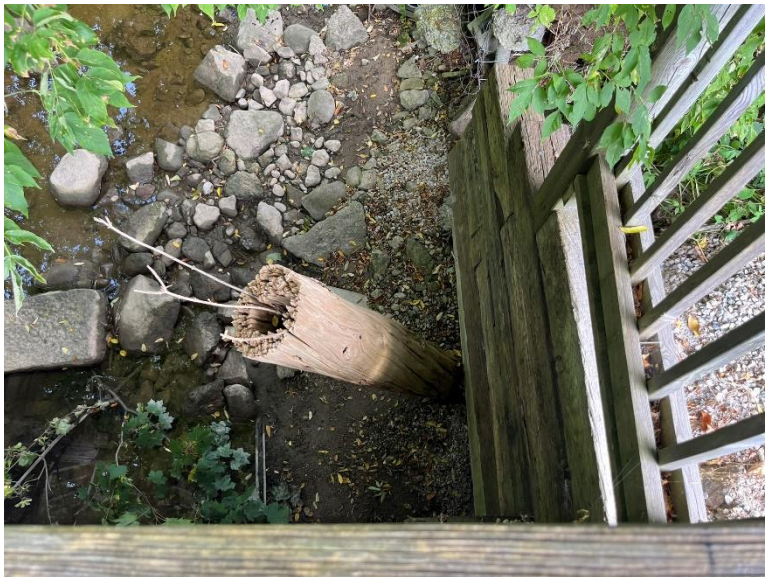
The piles meant to retain the ballast walls have also begun to lean inward (Figure 8). There is significant vegetative overgrowth and incursion throughout the ballast walls including a tree growing directly behind the wall on the north side of the structure on the west side of the waterway which is pushing the wall inward (Figure 9).

Figure 8: Detail view of the leaning northeastern ballast wall pile (A.S.I., 2024)

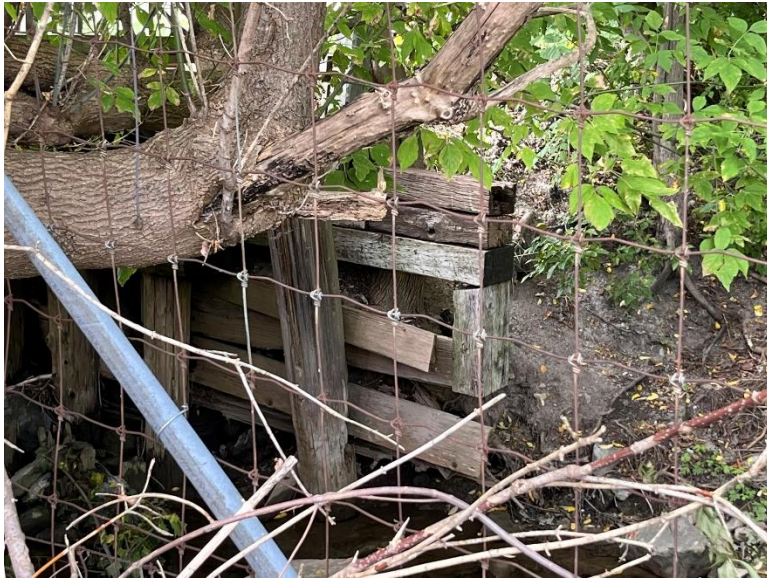
Figure 9: Detail view of the northwestern ballast wall. The tree pushing the wall inward is visible through the gap in the wall (A.S.I., 2024)

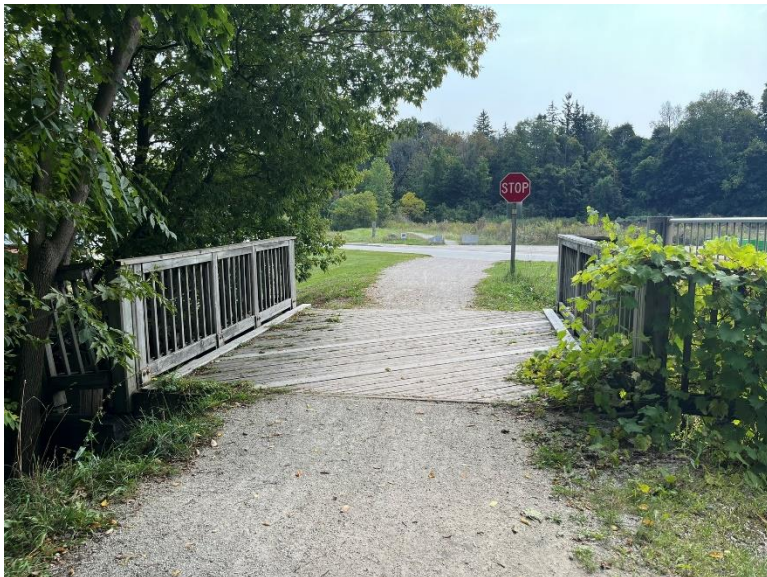
The deck of the subject bridge is constructed of timber planks laid diagonally across the width of the structure with timber curbs on either side (Figure 10 and Figure 11). There are timber railings which are bolted to the exterior of the superstructure. The timber deck and railing system were likely added when the bridge was converted for pedestrian use in 1989 and seem to be in good condition (Figure 12). At the northwest portion of the ballast wall, a tree growing alongside the wall has wound itself through the railing. The railing and a small portion of the bridge deck are overgrown with ivy at the southwest portion of the ballast wall (Figure 13).

Figure 10: The timber bridge deck, looking southeast (A.S.I., 2024).

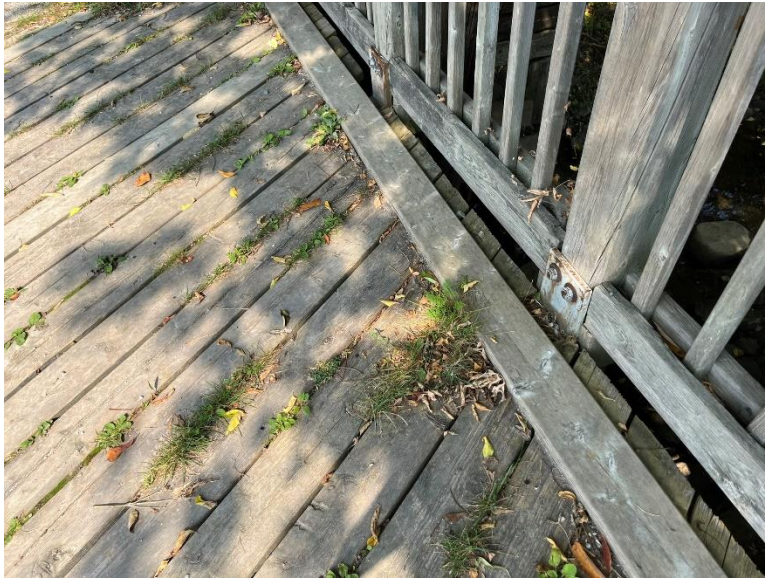
Figure 11: Detail view of the bridge deck and timber curb (A.S.I., 2024).

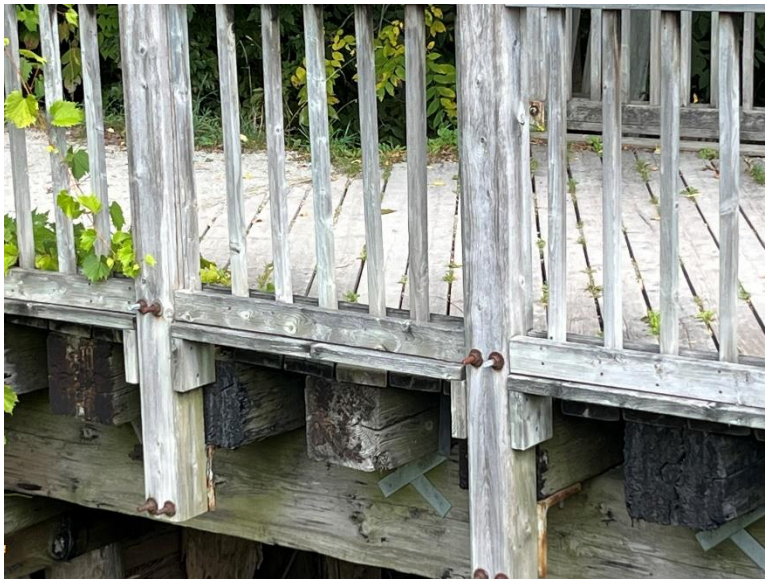
Figure 12: Detail view of the railing system on the southern elevation. Note the bolts connecting the railing to the superstructure (A.S.I., 2024).

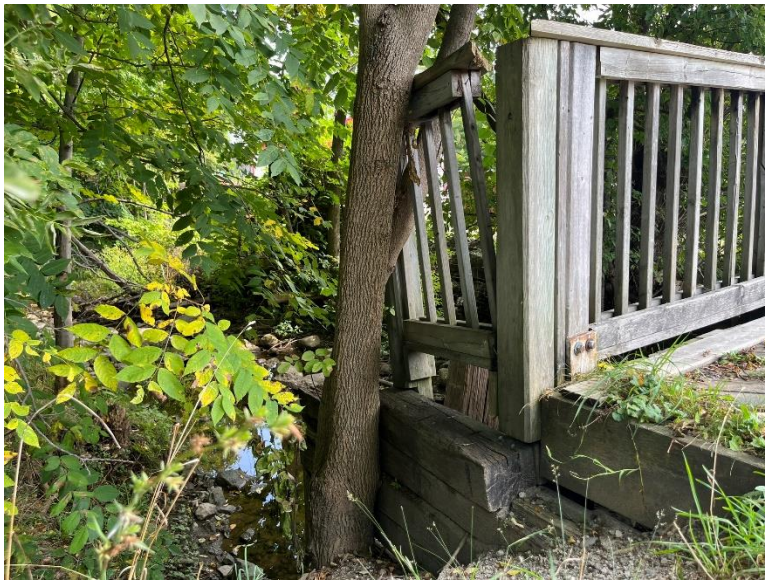
Figure 13: Detail view of the tree growing through the railing at the northwest ballast wall (A.S.I., 2024).
